# Technical Specifications Test Report-1

# TEST REPORT

No. : XMHL2306003347SD

Sample Name : CARRARA  
Material : DOLOMITE STONE  
Spec. : 100\*100\*20MM  
Manufacturer : XIAMEN SUPERIOR STONE CO.,LTD

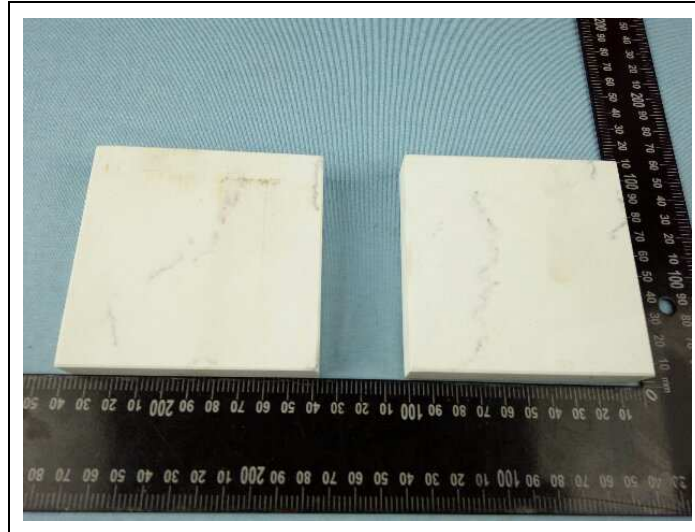
Specimen photograph:

Specimens: Agglomerated stone, 100mm×100mm×20mm, 6pcs, one face honed

Specimens: Agglomerated stone, 100mm×100mm×20mm, 3pcs, one face honed
